Electricity Effects on Bearings

By Eugenio Galban

Application example

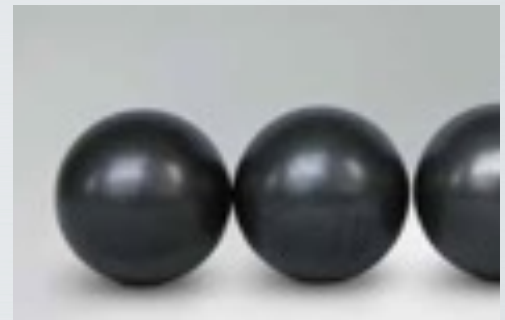
Figure 3. Electrical corrosion has a dark color that covers the entire ball surface [8]

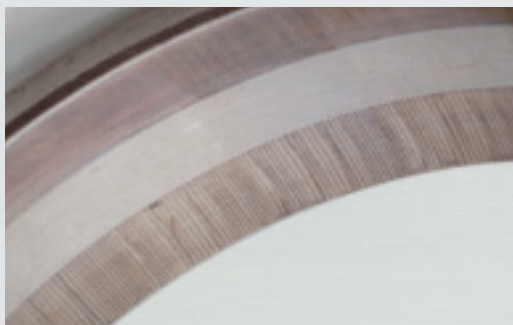
Another type of damage diagnosis related to electricity in bearings, is when the rolling surfaces shows a uniformly distributed fluting-craters appearance along the rolling surface [7]. This phenomenon occurs when the current intensity is relatively low, but it is applied for a long period of time. This is classified as Current Leakage or Washboarding.

Figure 4. Current Leakage or Washboarding damage. [3]

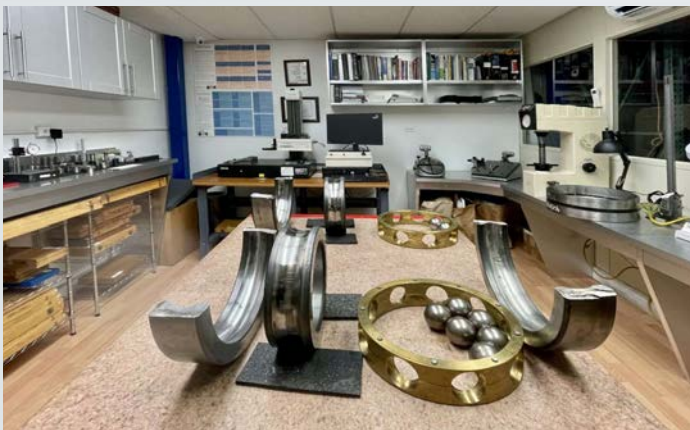
At the time of the external inspection the bearings were received, and components were separated and the rings raceways and rolling elements were inspected thoroughly.

The damaged bearings were classified for both sides as C4, I8 and D8.

Figure 9. Disassembled bearings ready for inspection at ABS facility.

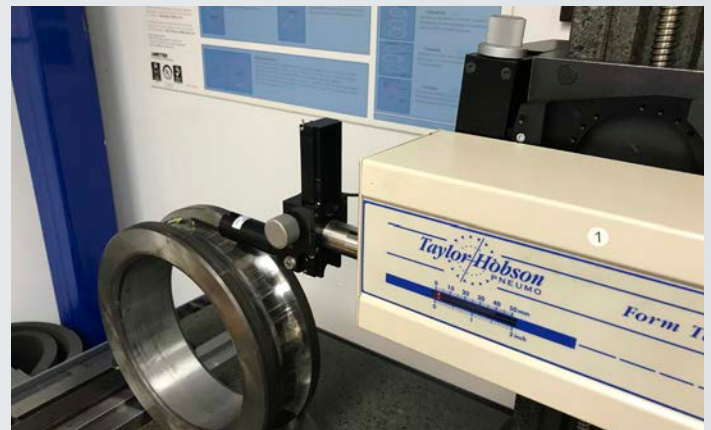
Figure 10. Inner ring surface quality inspection of the received bearings.

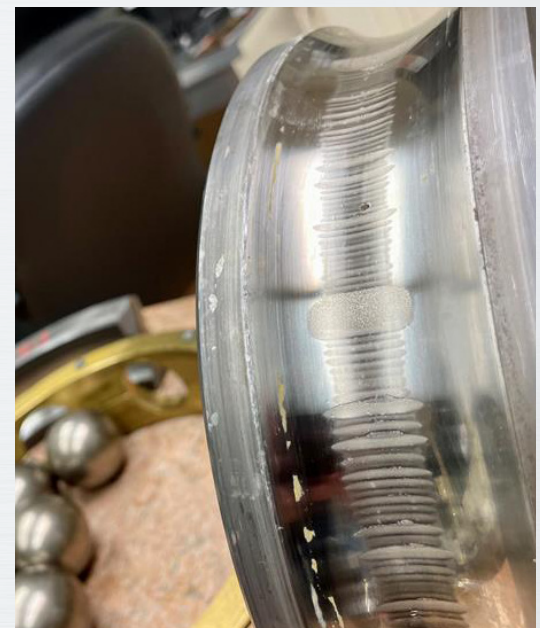
1. The Bearing C4 inner ring, drive end side, the raceway showed axial groove marks distributed uniformly along the rolling surface.

This type of failure is diagnosed as Electrical Fluting. bearings have been subjected to stray electrical current leakage over time due to parasitic electrical currents from the stator having electrolytic corrosion. This failure is known as Current Leakage. [3]

This type of damage will provoke high levels of vibration, noise, spalling and the base lubricant oil to burn and harden, causing poor lubrication condition.

Figure 11. Bearing C4 inner ring with Current Leakage damage

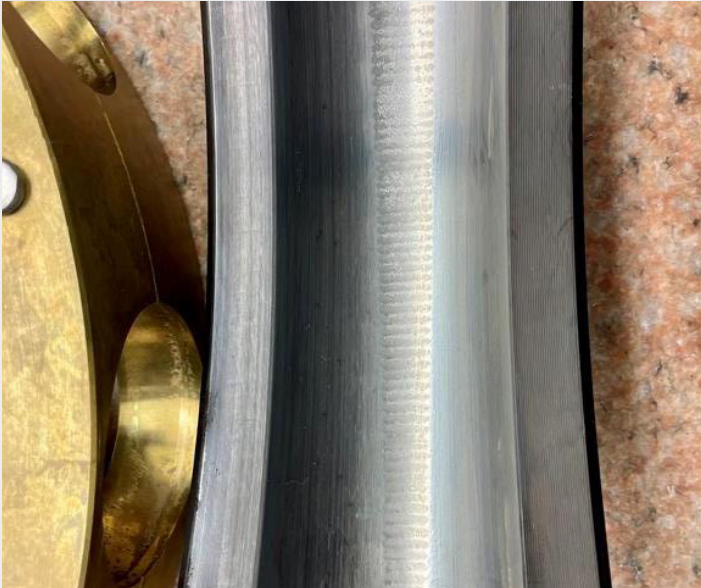
2. Bearing C4 outer ring raceway, drive end side, shows axial grooves and micro-pitting marks due to the electrical erosion damage, shown in Figure 12, 13 and 14.

The bearing has been subjected to stray electrical current leakage over time due to parasitic electrical currents from the stator having electrolytic corrosion. This failure is known as Current Leakage. [3]

Figure 12. Bearing C4 outer ring with Current Leakage damage

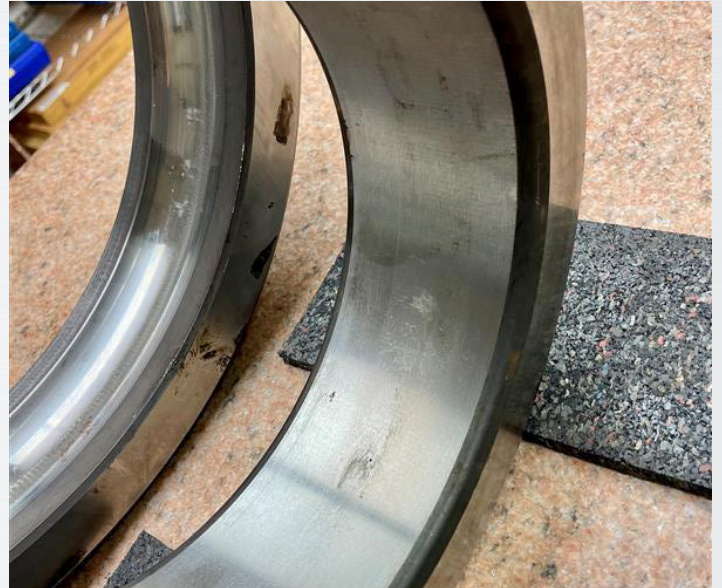
In addition, micro-pitting can be seen, what is known as Excessive Voltage as the electrical corrosion takes place.

Figure 13. Bearing C4 with Current Leakage and Excessive Voltage cratering damage

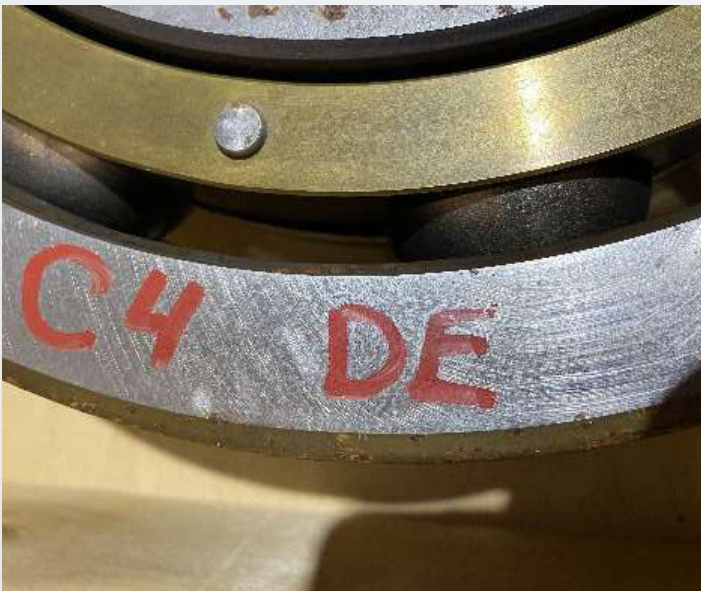
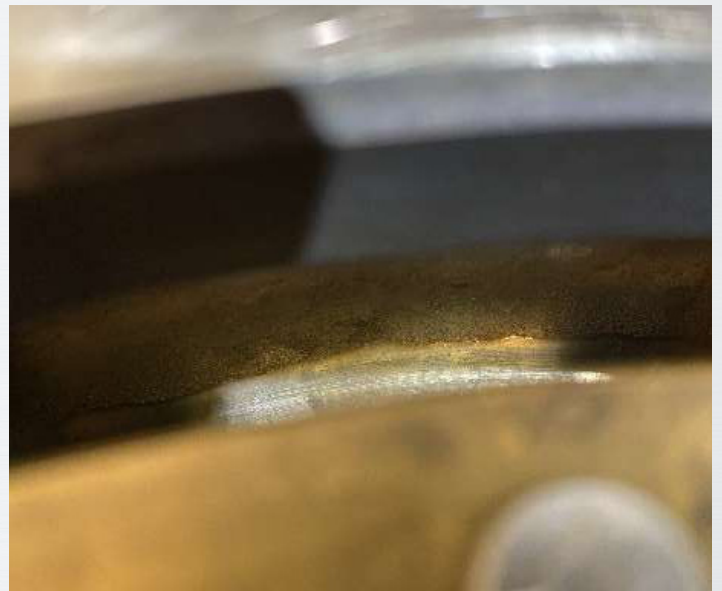
Figure 14-1. Bearing C4 with Electrical Erosion

Figure 14-2. Bearing C4 with Electrical Erosion

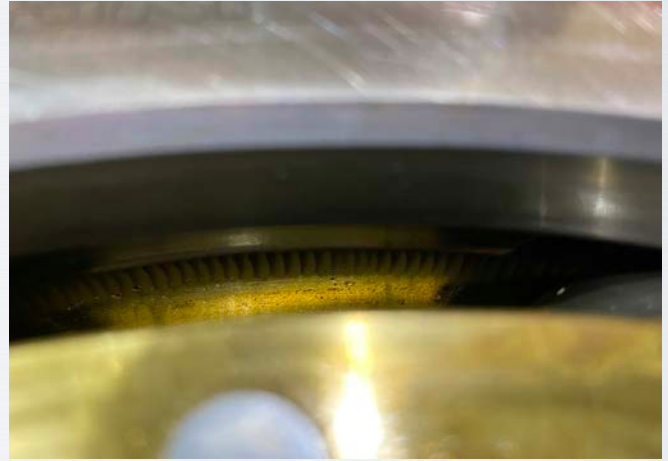
Bearing 18 outer ring raceway, drive end side, shows axial grooves and micro-cratering marks due to the electrical erosion damage, shown in Figures 15 and 16.

The damage of this bearing is like the damages found in the C4 bearing outer ring.

Figure 15. Bearing I8 with Current Leakage damage.

Figure 16. Bearing I8 with Electrical Erosion damage

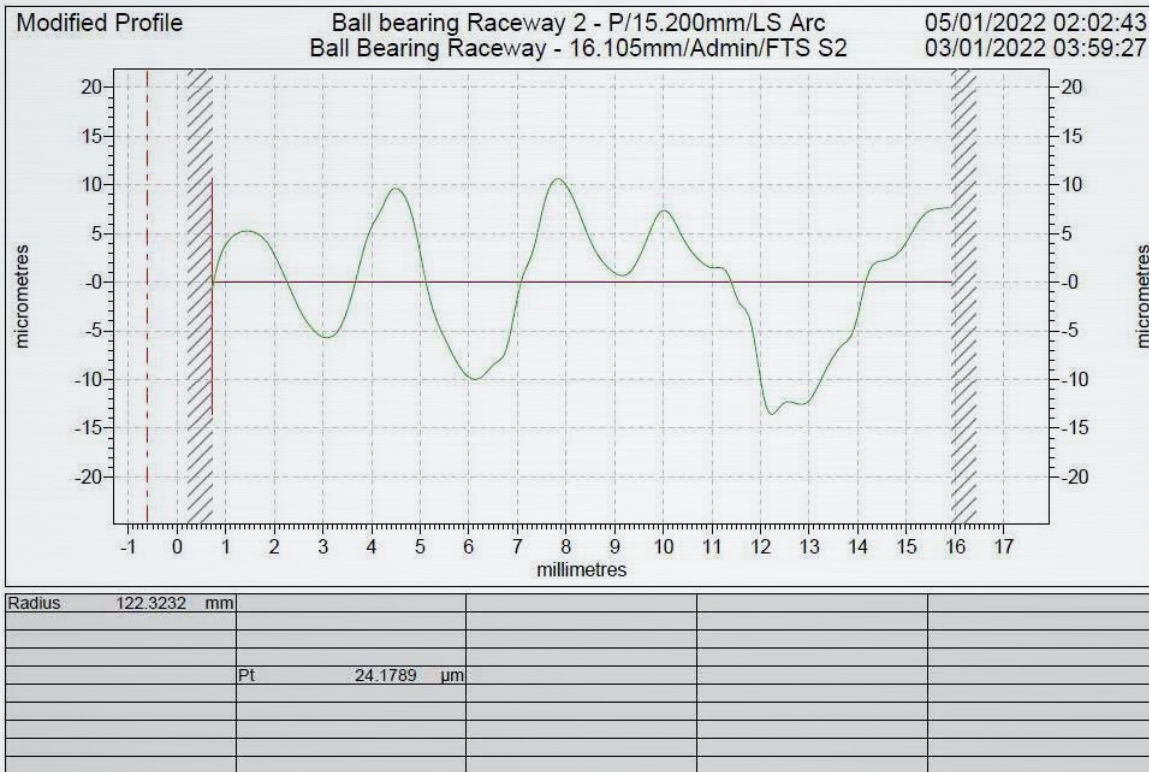
The analysis of the raceway using a Taylor-Hobson profilometer shows the damage occurred, the bearing cannot operate under this condition.

Figure 19. Bearing D8 inner ring raceway profilometer result
